IDAHO AIR NATIONAL GUARD GOWEN FIELD, BOISE, IDAHO

## SITE INSPECTION REPORT VOLUME I

## AIR NATIONAL GUARD INSTALLATION RESTORATION PROGRAM IDAHO AIR NATIONAL GUARD GOWEN FIELD, BOISE, IDAHO

March 21, 1989

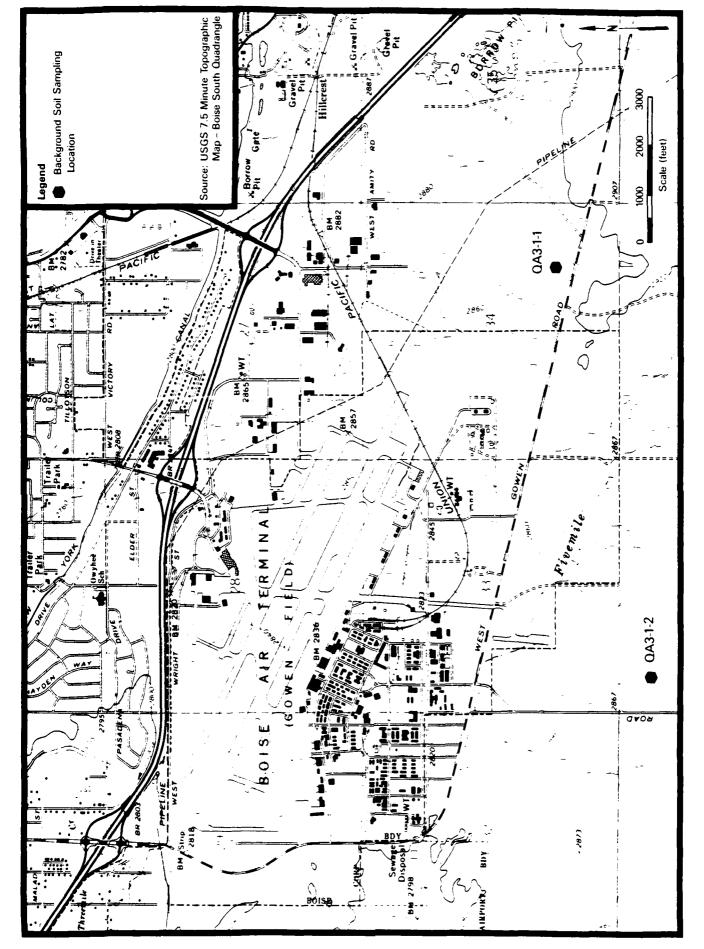
Figure 3-1. Background Soil Sample Location Map for Idaho Air National Guard, Gowen Field, Boise, Idaho.

Two soil samples were collected from remote locations off-base, away from any base activities that potentially could contaminate the soils. The locations where the background soils were collected are shown in Figure 3-1.

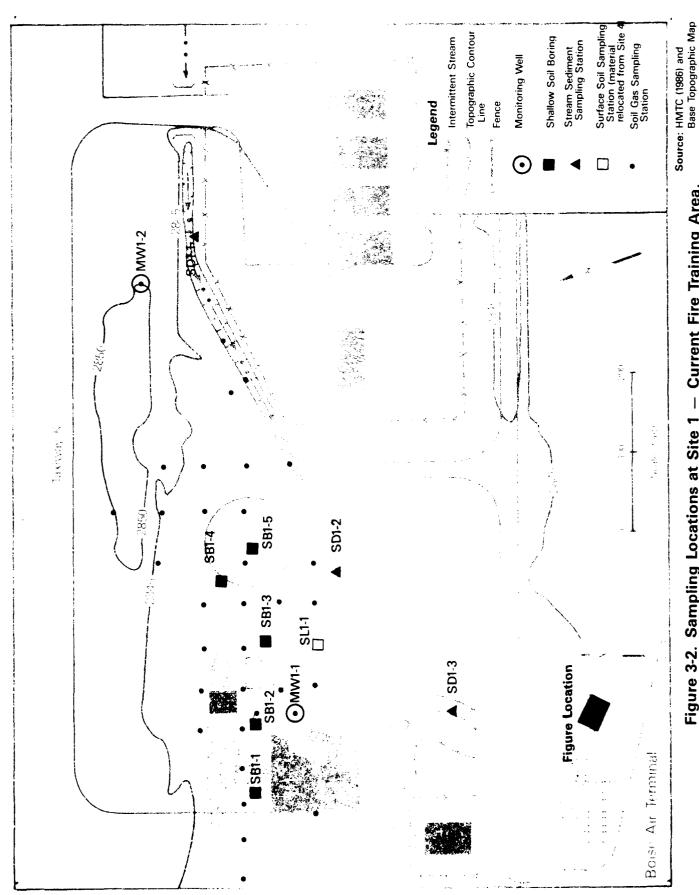
Figure 3-2. Sampling Locations at Site 1 - Current Fire Training Area, Idaho Air National Guard, Gowen Field, Boise, Idaho.

A soil gas survey was conducted at Site 1 - Current Fire Training Area. In addition, monitoring well soil boring samples and shallow soil boring samples were collected and analyzed. Figure 3-2 shows the sampling locations at Site 1.

Of the halocarbons analyzed for, TCE/CHBrCl<sub>2</sub> was the most frequently detected. The highest concentration of TCE/CHBrCl<sub>2</sub> (1,900 ug/L) was detected at a sampling location northeast of the Burn Pit. Among the other halocarbons analyzed for, concentrations (>0.01 ug/l) of PCE were detected at only three sampling locations.

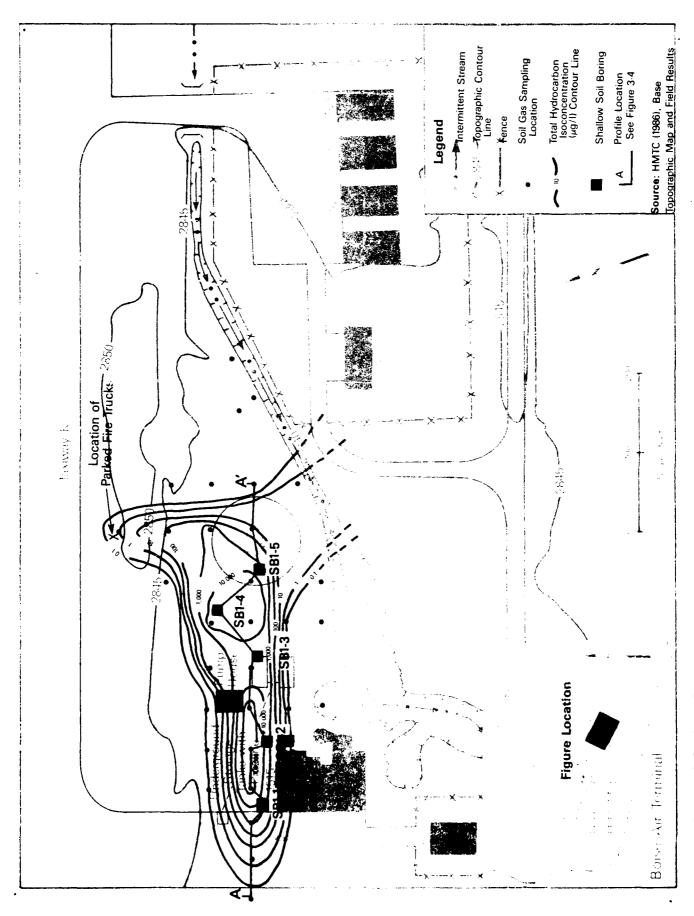
Figure 3-3. Soil Gas Isoconcentration Map for Total Hydrocarbons at Site 1 - Current Fire Training Area, Idaho Air National Guard, Gowen Field, Boise, Idaho.

by 150 feet with the long axis of the plume oriented in a northwest-southeast direction. Figure 3-3 shows the orientation of the plume at Site 1 - Current Fire Training Area. Total hydrocarbon concentrations were found to be highest (400,000 ug/l) at a location northwest of the underground storage tanks. Two other samples taken from the Burn Pit showed concentrations of 98,000 and 46,000 ug/l total hydrocarbons. Distribution of toluene at Site 1 was similar to that of the total hydrocarbons.

The soil gas survey located three areas at Site 1 - Current Fire Training Area as primary sources of contamination. Northwest of the underground storage tanks is a source of hydrocarbon contamination where underground plumbing exists that transfers fire training fuels from a trough on the edge of the tarmac to the underground storage tanks. Second, an area northwest of the Burn Pit, where there formerly was underground plumbing that transferred fire-fighting fuels from the underground storage tanks to the Burn Pit, is a source of hydrocarbon and CHBrCl<sub>2</sub> contamination. The CHBrCl<sub>2</sub> exists because this location is also the area where the fire training trucks discharge their fire-fighting agents, which contain CHBrCl<sub>2</sub>, during fire training exercises. Third, the Burn Pit itself is a source of hydrocarbon contamination.

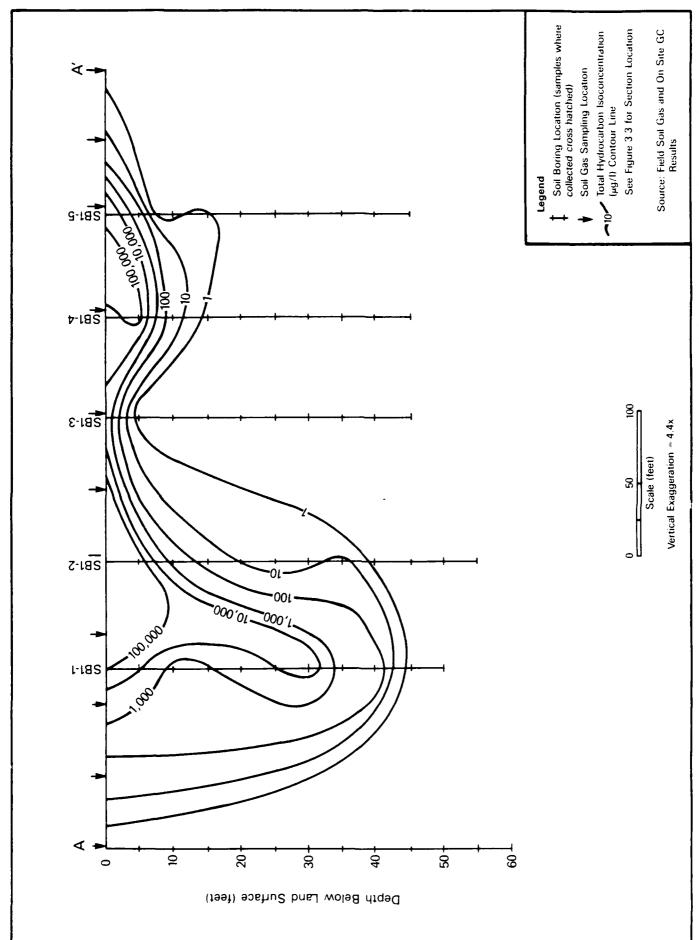
Figure 3-4. Isoconcentration Profile Map of Total Hydrocarbons from Soil Gas and On-Site GC Data at Site 1 Current Fire Training Area, Idaho Air National Guard, Gowen Field, Boise, Idaho.

ug/kg), and total hydrocarbons (370,000 ug/kg). Figure 3-4 presents the isoconcentration profile map, which shows the vertical extent of the most prevalent contaminant found at the site, total hydrocarbons. These maximum concentration locations correlated well with the maximum concentration locations found curing the soil gas survey, confirming the source locations of contamination at the site. None of these compounds was found below the 45-foot depth.

The shallow soil borings showed the vertical extent of contamination to be no deeper than 45 feet and concentrated principally within 5 to 10 feet of the surface. The borings also correlated well with the soil gas survey, confirming contaminant source locations. Full off-site laboratory analyses of several of the samples showed that the contamination is the result of fuels leakage, consisting primarily of organic fuel constituents. Also, CHBrCl<sub>2</sub>, which was found in the soil gas survey, was not found at any depth below land surface in the soil borings.

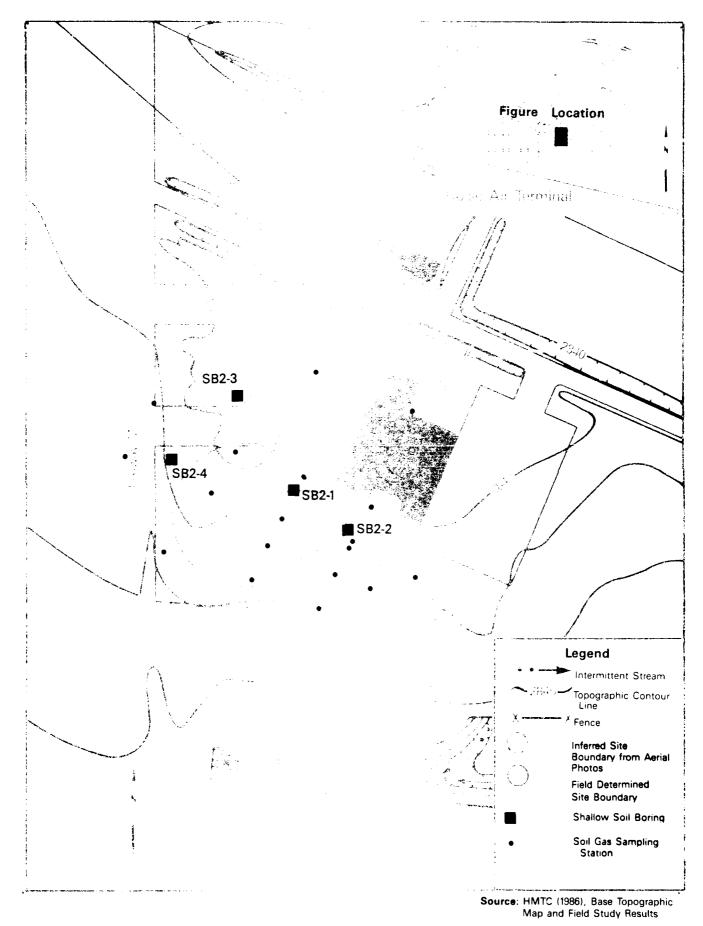
Figure 3-5. Sampling Locations at Site 2 — Former Fire Training Area, Idaho Air National Guard, Gowen Field, Boise, Idaho.

A soil gas survey was conducted at Site 2 - Former Fire Training Area. Then, to characterize further the potential soil contamination at the site, shallow soil boring samples were collected and analyzed. Figure 3-5 shows the sampling locations for the soil gas survey and the soil borings at Site 2.

Soil gas was collected and analyzed at 18 locations at Site 2 - Former Fire Training Area. All of the samples were analyzed for halocarbon and hydrocarbon contamination. Details of the survey results are contained in Volume II, Appendix F (Soil Gas Results). TCE/CHBrCl<sub>2</sub> was the most widespread halocarbon contaminant found at Site 2. The most elevated concentration (2 ug/l) of TCE/CHBrCl<sub>2</sub> was detected at a sampling location northwest of Building 1500, and the compound was found to extend approximately 250 feet southeast of that location.

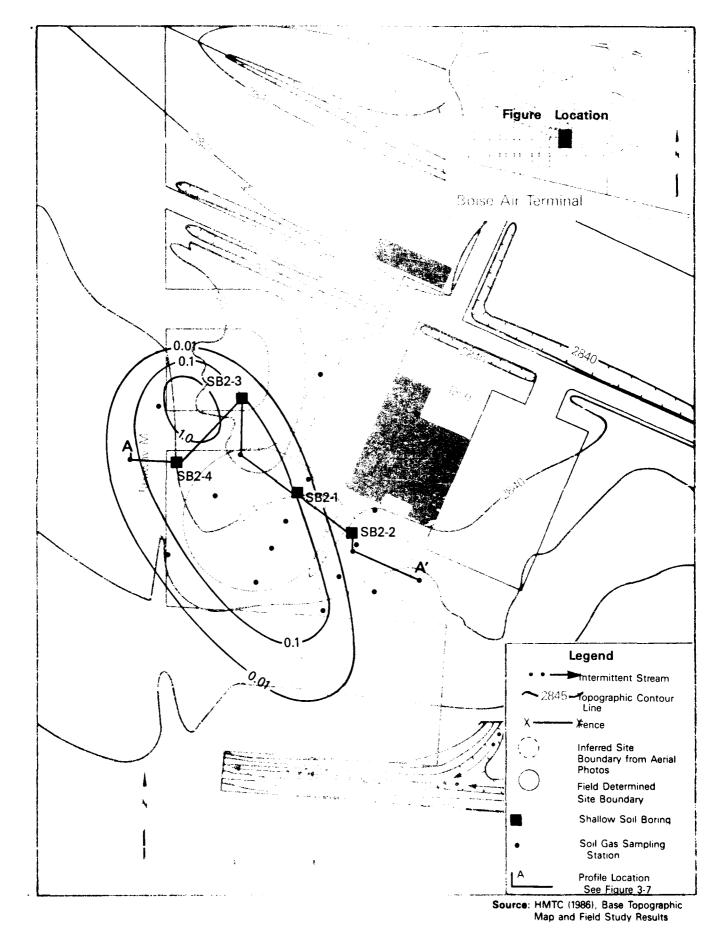
Figure 3-6. Soil Isoconcentration Map for Trichloroethene/Bromodichloromethane at Site 2 — Former Fire Training Area, Idaho Air National Guard, Gowen Field, Boise, Idaho. 3-32

Figure 3-6 presents the soil isoconcentration map for TCE/CHBrCl<sub>2</sub> at Site 2 - Former Fire Training Area. As shown in the figure, the levels of TCE/CHBrCl<sub>2</sub> are on the order of 0.01 to 2 ppb, which are barely above detection limits. In general, the results of contaminant analyses, including total hydrocarbons, trichloroethylene, tetrachloroethylene, toluene, and xylene, showed either no contaminants detected or very low concentrations (ppb to ppt) of contaminants at Site 2. At one location south of Building 1500, total hydrocarbons and xylenes were detected. At a soil gas sampling location

5 feet away, however, no contaminants were detected. Therefore, this appears to be a localized anomaly and not due to fire-fighting activities at the site.

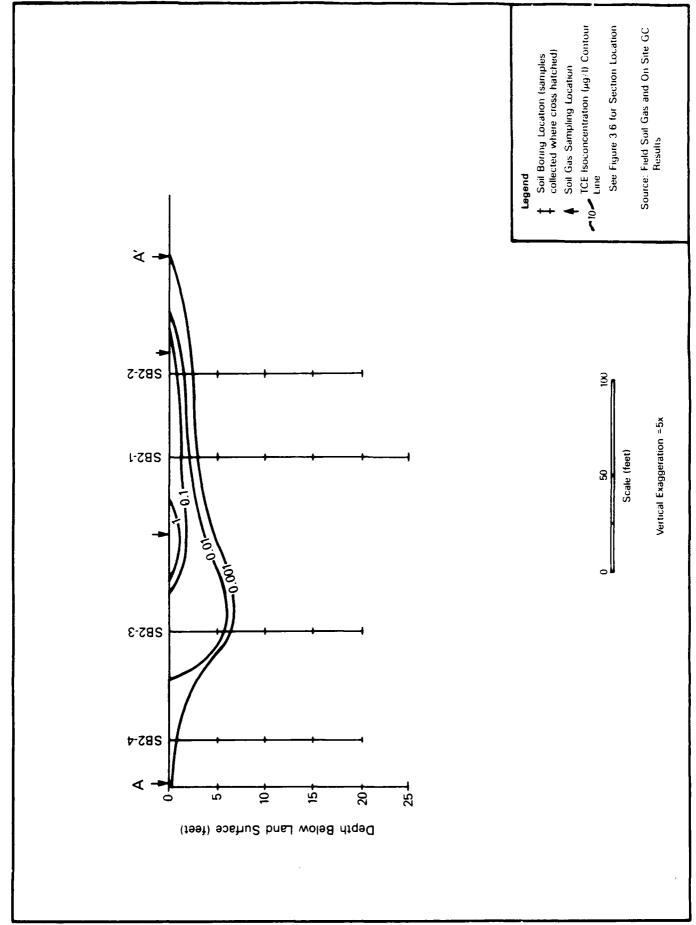
Figure 3-7. Isoconcentration Profile Map of Trichloethylene (TCE) from Soil Gas and On-Site GC Data at Site 2 - Former Fire Training Area, Idaho Air National Guard, Gowen Field, Boise, Idaho.

Four soil samples each were collected from four boring locations at depths of 5, 10, 15, and 20 feet BLS. The four soil borings were labeled SB2-1, SB2-2, SB2-3, and SB2-4. On-site GC results, which are in Volume II, Appendix G (On-Site GC Results) indicated the presence of TCA (0.01-0.02 ug/kg), TCE (0.07 ug/kg), and PCE (0.02-0.07 ug/kg). Again, these concentrations are very low (ppb to ppt level) and near the detection limits. The compounds of fuel (i.e., xylene, benzene, and toluene) and total hydrocarbons were not detected in soils sampled from the shallow borings and analyzed with the on-site GC. An isoconcentration profile map, shown in Figure 3-7, was constructed for TCE at Site 2 - Former Fire Training Area from the soil gas and on-site GC data. As shown in this figure, the highest concentration was found in one area at less than 1 ppb (ug/l for soil gas, ug/kg for on-site GC). As stated above, all other concentrations of TCE, where detected in soil gas or soil samples, were in the ppb to ppt range.

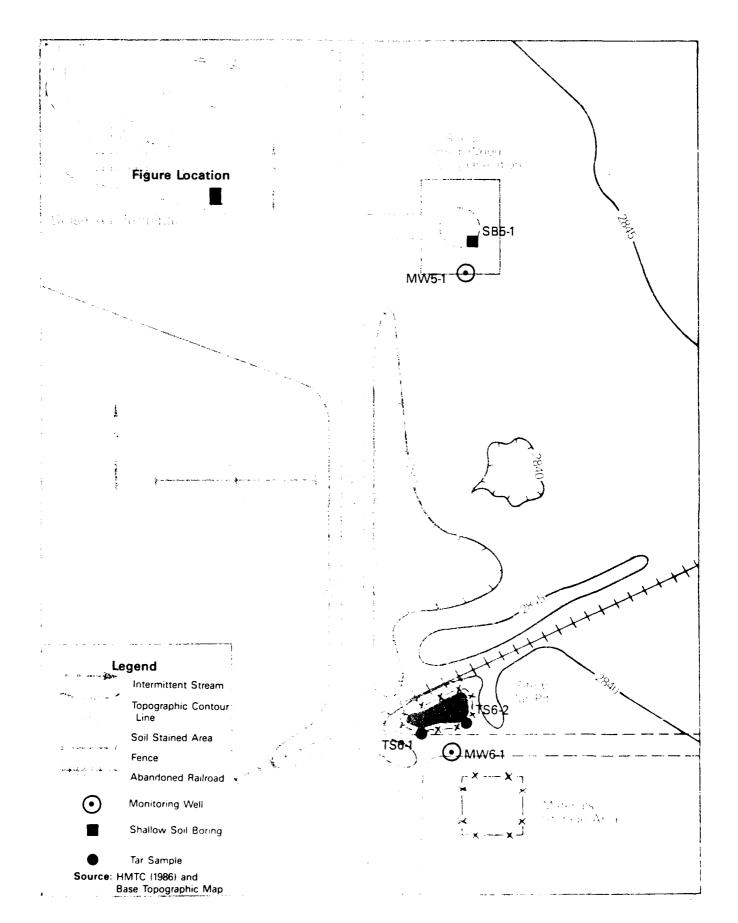
Figure 3-8. Sampling Locations at Site 5 — Former Wood Preserving Operation and Site 6 — Tar Pit, Idaho Air National Guard, Gowen Field, Boise, Idaho.

Shallow soil boring samples and monitoring well soil boring samples were collected and analyzed to characterize the contaminants at Site 5 - Former Wood Preserving Operation. Figure 3-8 presents the sampling locations at the site.

(On-Site GC Results). Low levels of TCA (0.01-0.02 ug/kg) and PCE (0.007-0.01 ug/kg) were detected in the majority of the soil samples. In addition, four of the nine soil samples were collected from one boring location (SB5-1) at depths of 5, 25, 35, and 55 feet BLS and were sent to the off-site laboratory for chemical analyses. The samples were analyzed for inorganics, petroleum hydrocarbons, volatile organics, and semi-volatile organic compounds. The results of the analyses are presented in Table 3-9. Arsenic, beryllium, chromium, copper, and nickel were among the inorganic compounds detected, all at concentrations near or below background soil concentrations. Zinc was detected in one soil sample at a depth of 35 feet BLS, at a concentration (230 mg/kg) higher than the background concentration. This is not considered to be a problem, because zinc was found in all laboratory method blanks and in the associated field blank and is considered to be a laboratory contaminant.

Monitoring well soil boring samples were collected to define the soil contamination at Site 6 - Tar Pit. Tar samples were collected from the pit to determine if the material could be characterized as a hazardous waste. Figure 3-8 shows the sampling locations at Site 6.

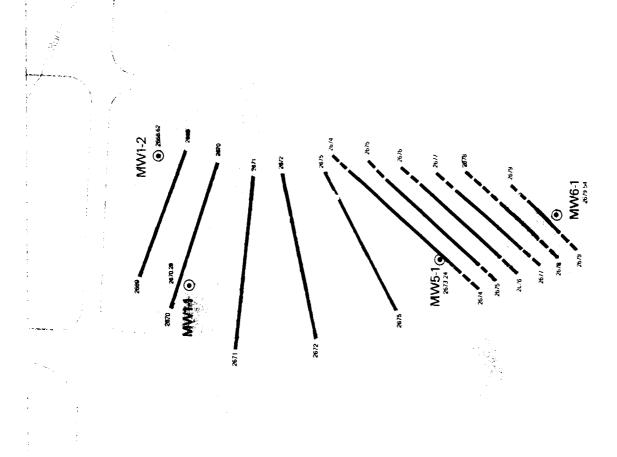
Figure 3-9. Water Table Elevation Contour Map, June 2, 1987, Idaho Air Naticnal Guard, Gowen Field, Boise, Idaho.

The groundwater table maps shown in Figures 3-9 and 3-10 illustrate that groundwater flow is variable, but is generally in a northerly direction (flow direction is perpendicular to equipotential lines). Also, the consistent drop of levels in the wells between the two measurement dates indicates that the groundwater flow direction did not significantly change from spring to late summer of 1987 or to winter of 1989, as shown in Figures 3-9 and 3-10 and in Table 3-12. This northerly direction is significantly different from the southerly direction specified in earlier reports, indicating that the lining of the New York Canal northwest of Gowen Field in the late 1970's has reduced seepage of irrigation water into the aquifer. This seepage had been the cause of a groundwater mound, resulting in the previous southerly groundwater flow direction in the Gowen Field area, noted in earlier reports.

Based on the groundwater table maps provided in Figures 3-9 and 3-10, monitoring well MWl-2 is downgradient to cross-gradient of Site 1 - Current Fire Training Area, while the remaining monitoring wells (MWl-1, MW5-1, and MW6-1) are slightly upgradient to cross-gradient of their respective sites. This differs from the originally proposed well locations, where monitoring wells MWl-1, MW5-1, and MW6-1 were to be located downgradient and MWl-2 was

The hydraulic gradient (I) is the change in hydraulic head per unit horizontal distance measured along a groundwater flowline, or, in other words, the slope of the water table. Using the water table surface maps, shown in Figures 3-9 and 3-10, calculations yielded a value of hydraulic gradient of 0.008, or 42 feet per mile. This hydraulic gradient is steeper and more varied than expected for a deep, high hydraulic conductivity water table aquifer (values of I from Dion 1972 were from 16 to 19 feet per mile). Possible reasons for this hydrologic anomaly are:
